PRECEDENCE 1 INSPECTIONS

INTERNACHI RESIDENTIAL

1234 Main Street
North Las Vegas, NV 89031

02/18/2025 9:00AM

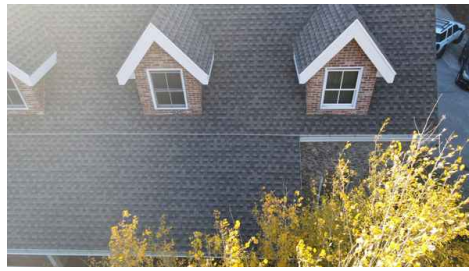
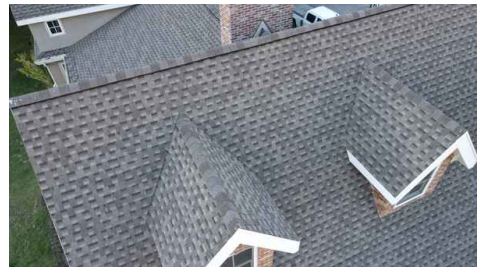
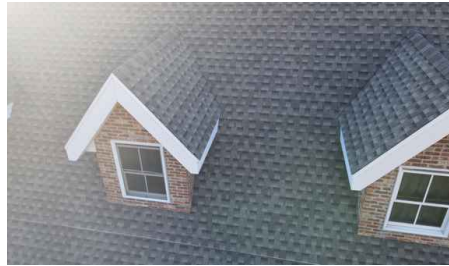
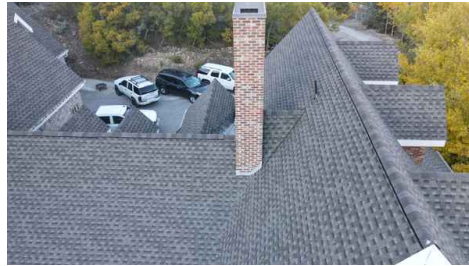
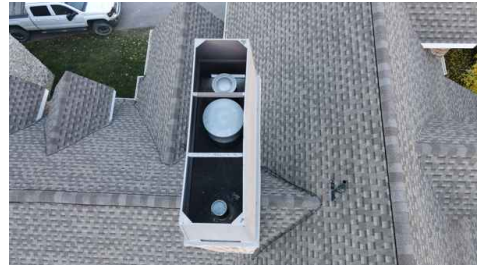
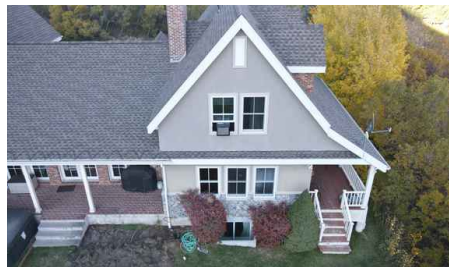
Flashing Details

I looked for flashing where the roof covering meets a wall or siding material. There should be step and counter flashing installed in these locations. This is not an exhaustive inspection of all flashing areas.

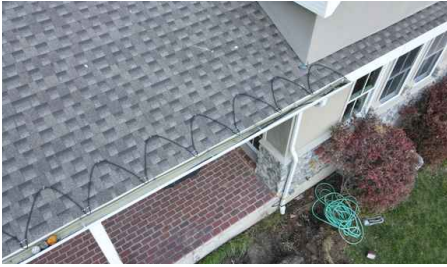
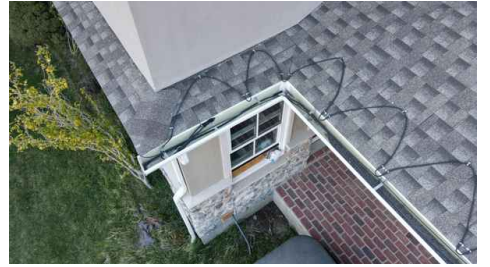
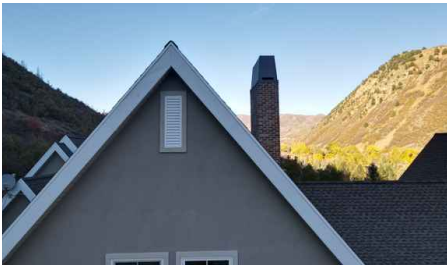
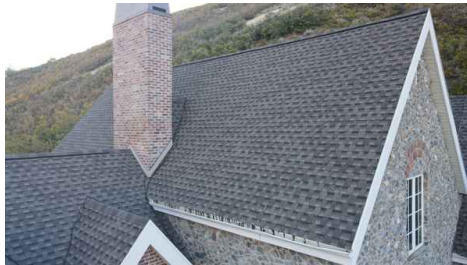
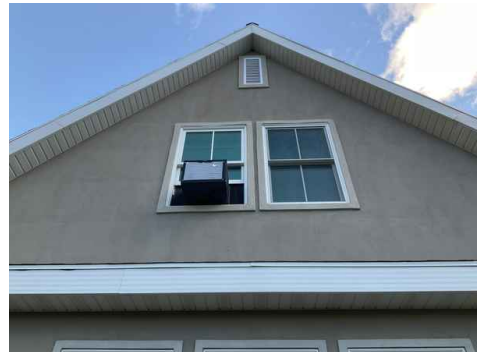
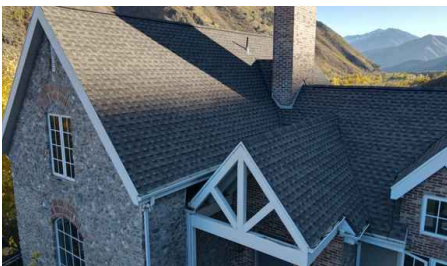
Flashing: Eaves and Gables

I looked for flashing installed at the eaves (near the gutter edge) and at the gables (the diagonal edge of the roof). There should be metal drip flashing material installed in these locations. The flashing helps the surface water on the roof to discharge into the gutter. Flashing also helps to prevent water intrusion under the roof-covering.

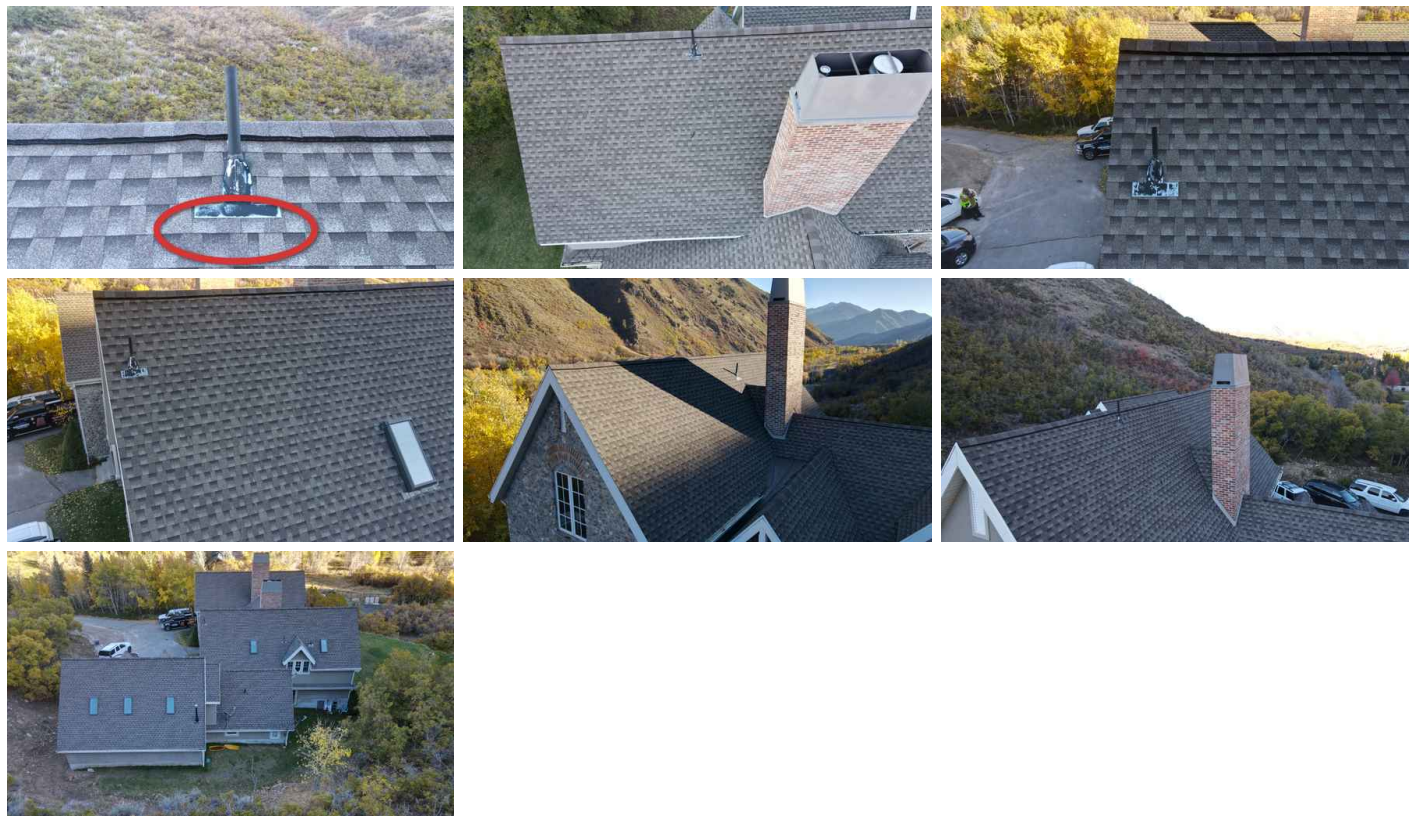
Plumbing Vent Pipes: Plumbing Vent Pipes Inspected

I looked at DWV (drain, waste and vent) pipes that pass through the roof covering. There should be watertight flashing (often black rubber material) installed around the vent pipes. These plumbing vent pipes should extend far enough above the roof surface.

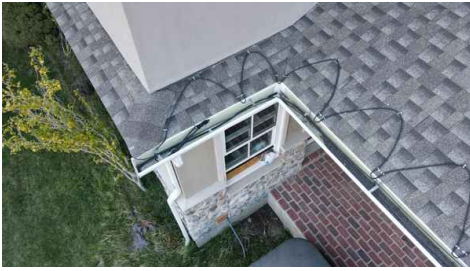
2.5.1 Gutters & Downspouts

DEBRIS IN GUTTERS

Debris inside gutter

Contact a qualified gutter contractor

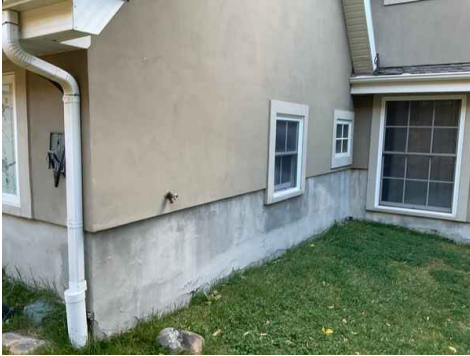
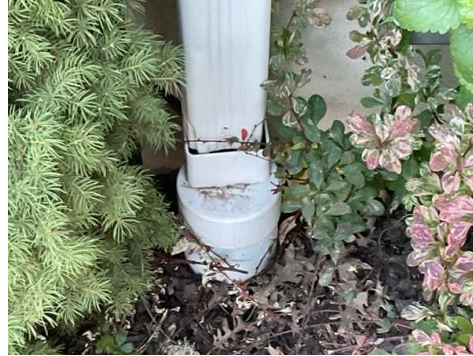
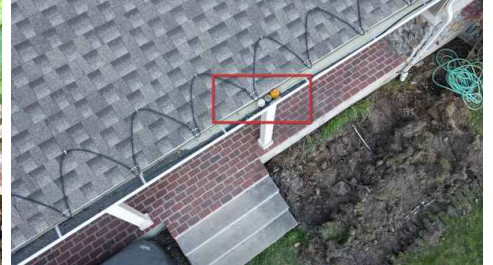
Debris stuck in the gutter

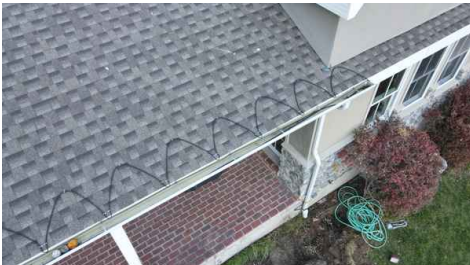
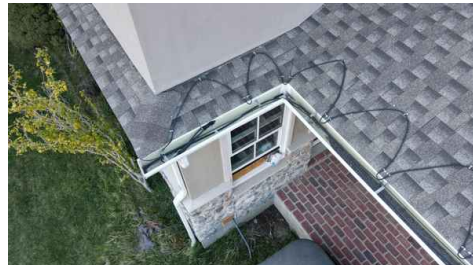
GUTTER DAMAGED

I observed damage to the gutter. This is a defect that should be corrected by a professional contractor.

Contact a qualified gutter contractor

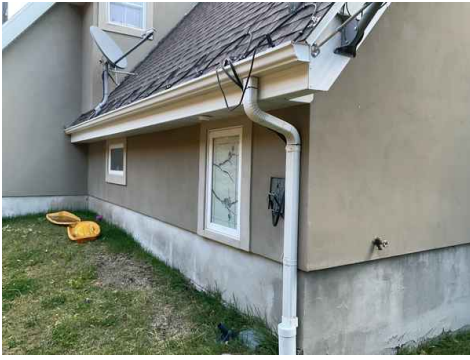
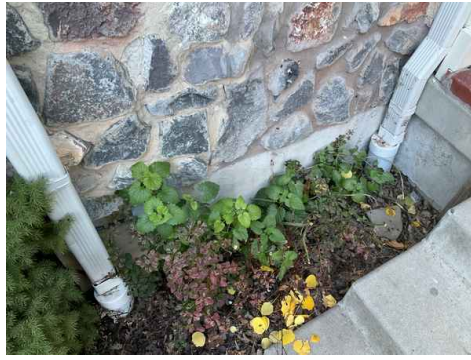
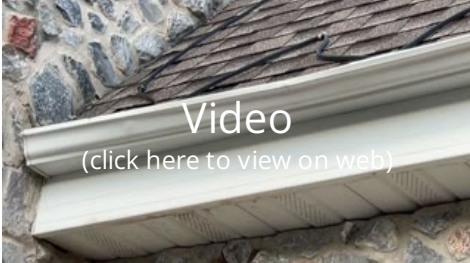
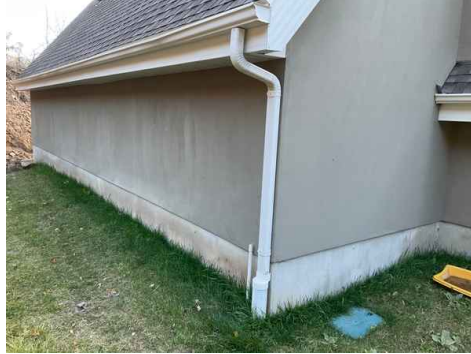
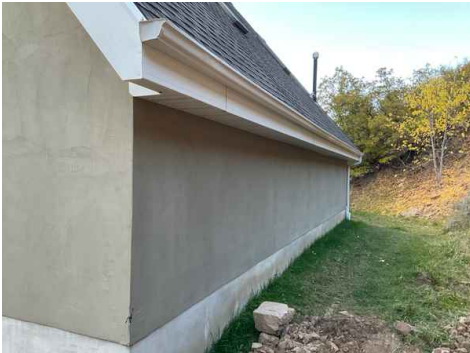
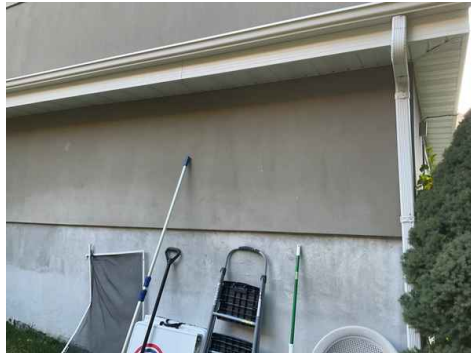
2.5.3 Gutters & Downspouts

One or more downspouts drain too close to the home's foundation. This can result in excessive moisture in the soil at the foundation, which can lead to foundation/structural movement. Recommend a qualified contractor adjust downspout extensions to drain at least 6 feet from the foundation. A handy homeowner should be able to do this project.

Recommended DIY Project

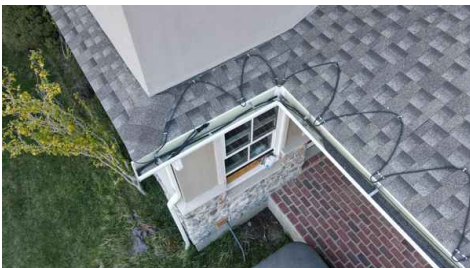
2.5.4 Gutters & Downspouts

DOWNSPOUT DETACHED

I observed indications of a disconnected and detached downspout pipe. Easy fix.

Contact a qualified roofing professional.

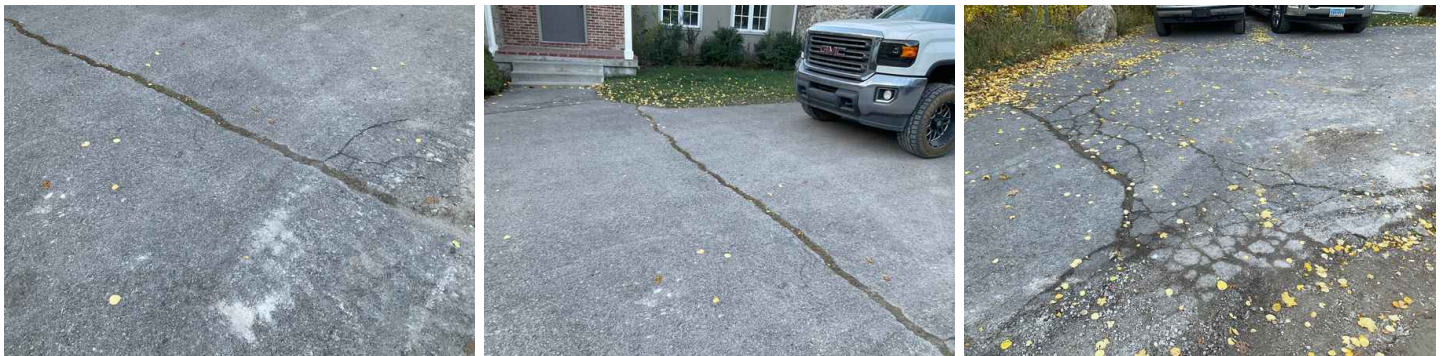
**MINOR CRACKING AT WALKWAY**

I observed minor cracking and no major damage at the walkway.

Monitoring is recommended.

Contact a handyman or DIY project

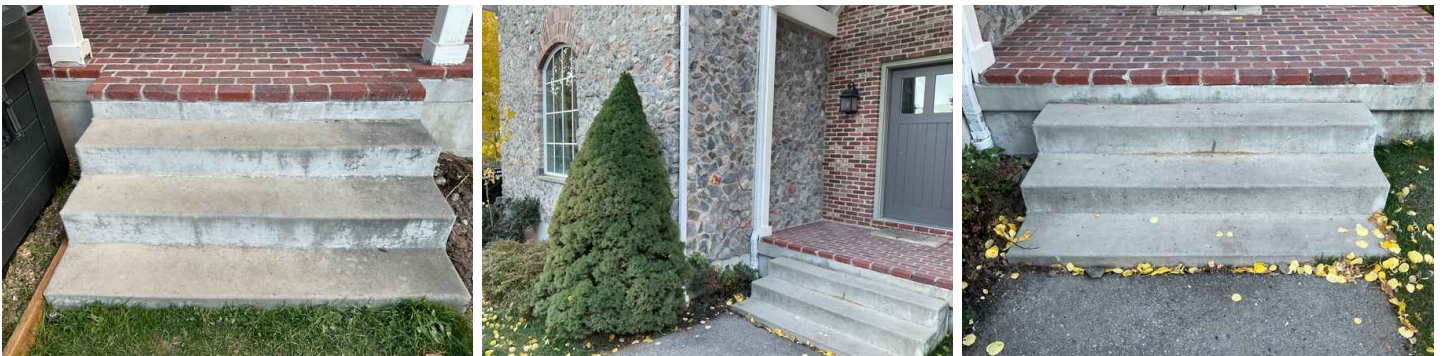
I observed a defect at the stair riser height.

The riser height maximum is 7 3/4 inches measured vertically between the stair treads. This poses a trip hazard.

Contact a qualified professional.

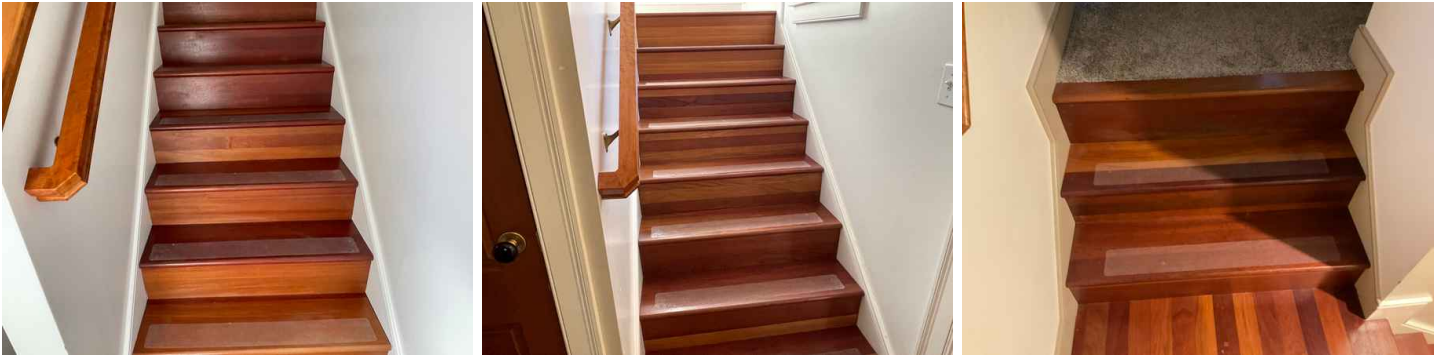
3.7.4 Stairs, Steps, Stoops, Stairways & Ramps

TREAD DEPTH TOO SHORT (SMALLER THAN 10")

I observed a defect at the stair riser depth. It's too short.

The minimum tread depth is 10 inches, measured between the projected nosings of adjacent treads. This poses a trip hazard.

Contact a qualified professional.

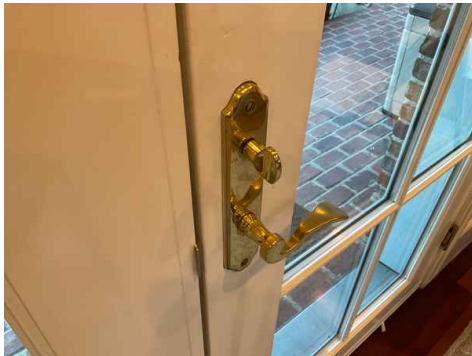
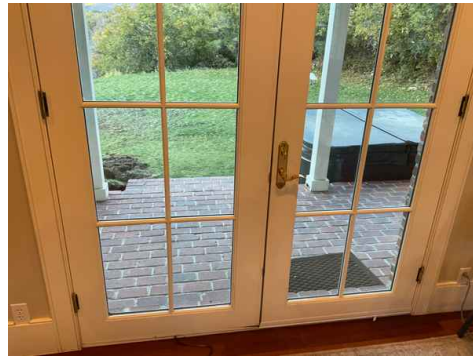
DOOR HARDWARE DAMAGED

I observed damage at the exterior door hardware.

Correction and further evaluation is recommended.

Recommended DIY Project

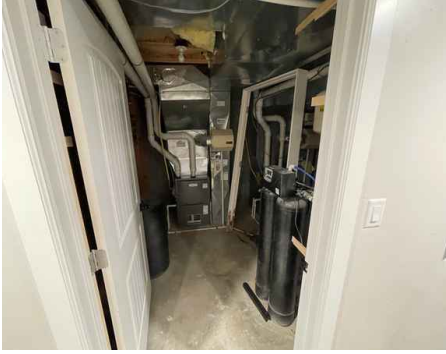
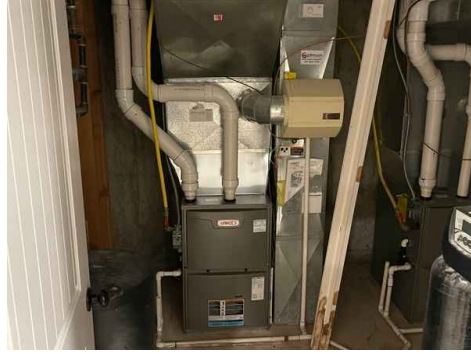
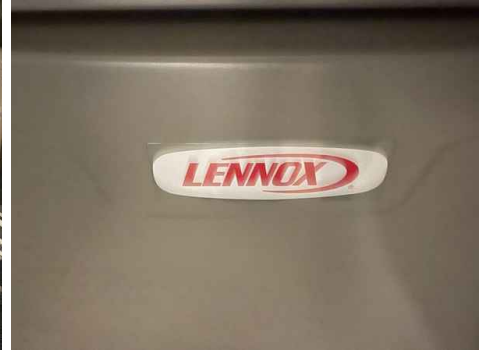
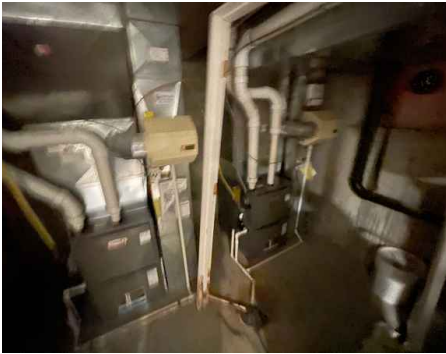
Heating System Information: Heating Method

Warm-Air Heating System

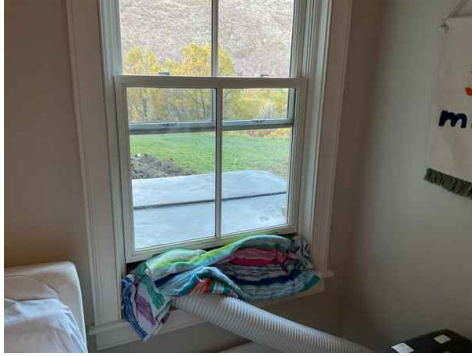
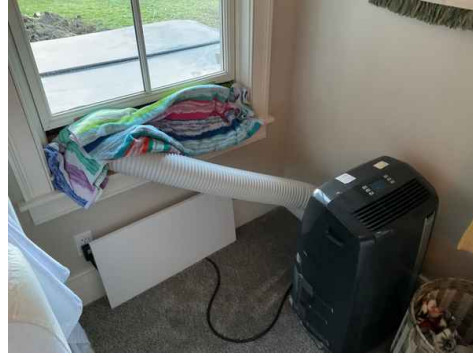
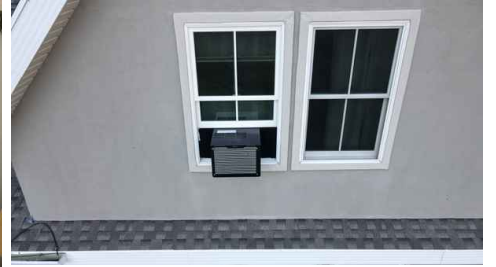
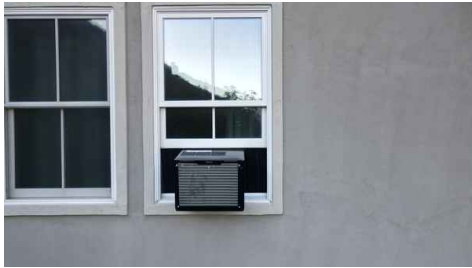
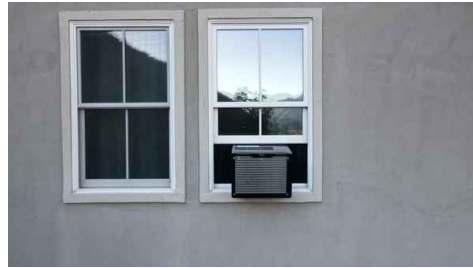
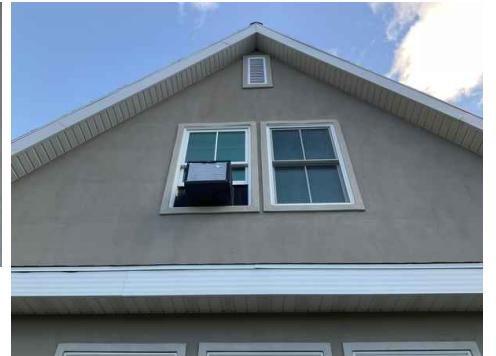
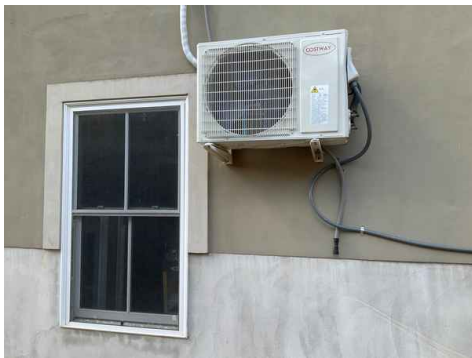
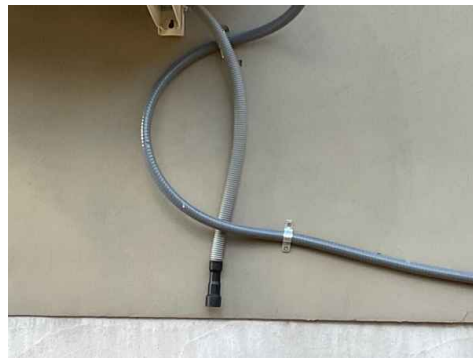
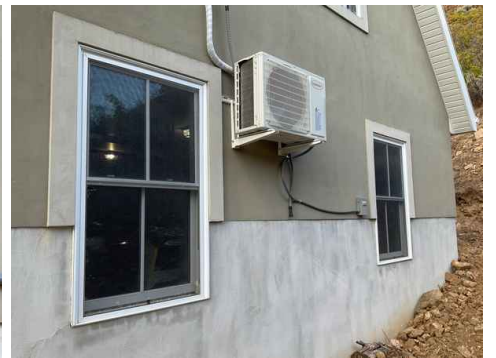
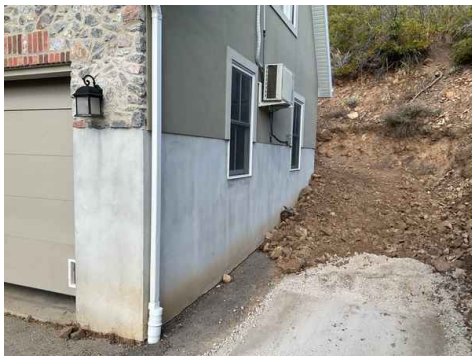
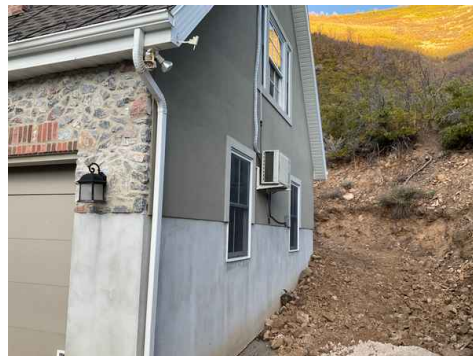
5.1.2 Cooling System Information

I observed that the cooling system was turned off prior to my home inspection.

Condensing unit can be damaged if it's operated immediately after power is restored. Recommend power be restored for at least 8 hours and unit evaluated by licensed HVAC contractor.

Contact a qualified HVAC professional.

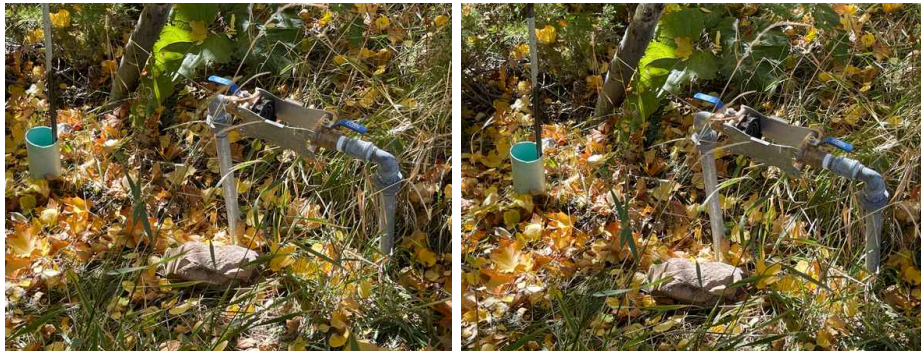
Main Water Shut-Off Valve: Location of Main Shut-Off Valve

Exterior left side of house
Outside of House

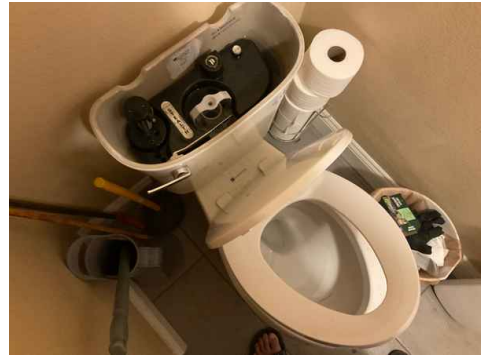
TOILET TANK COMPONENT DEFECT

I observed indications of a toilet that had tank components that did not operate.

Contact a qualified plumbing contractor.

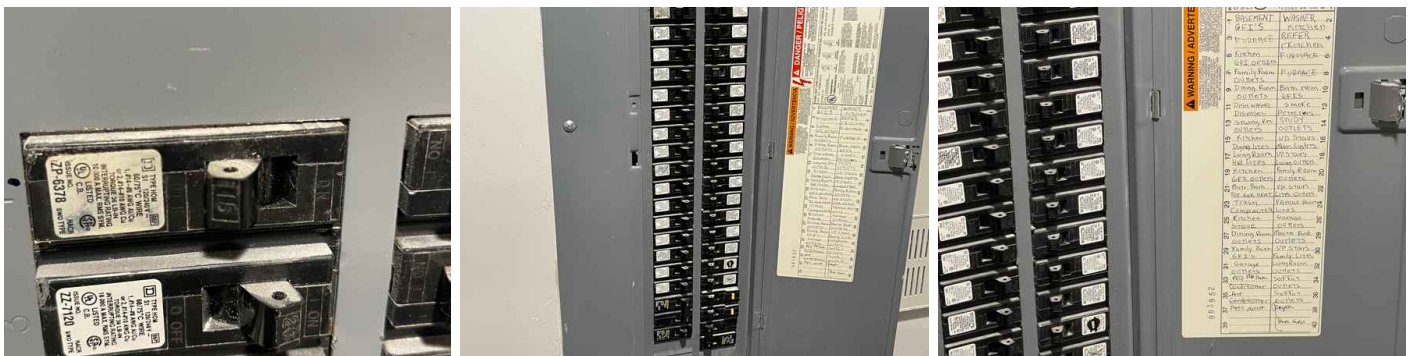
Panelboards & Breakers: Inspected Main Panelboard & Breakers

I inspected the electrical panelboards and over-current protection devices (circuit breakers and fuses).

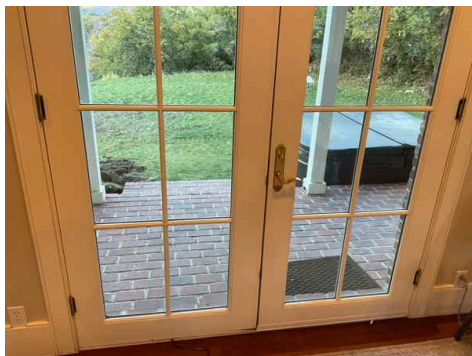
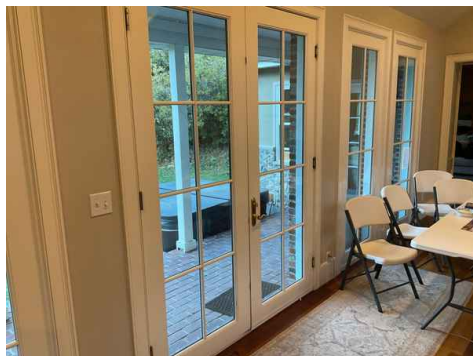
I observed that the door sticks.

Contact a qualified handyman.

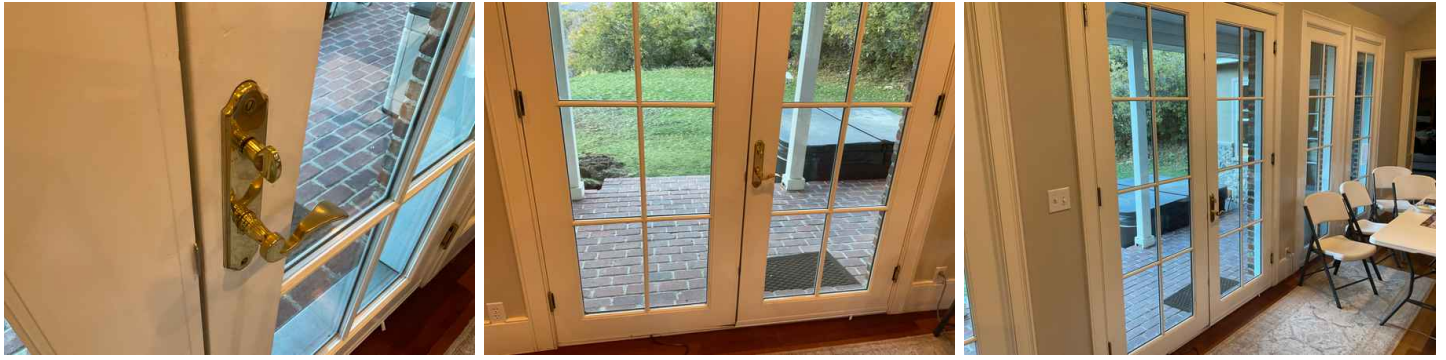
DAMAGED DOOR HARDWARE

I observed damage to the door hardware.

Contact a qualified door repair/installation contractor.

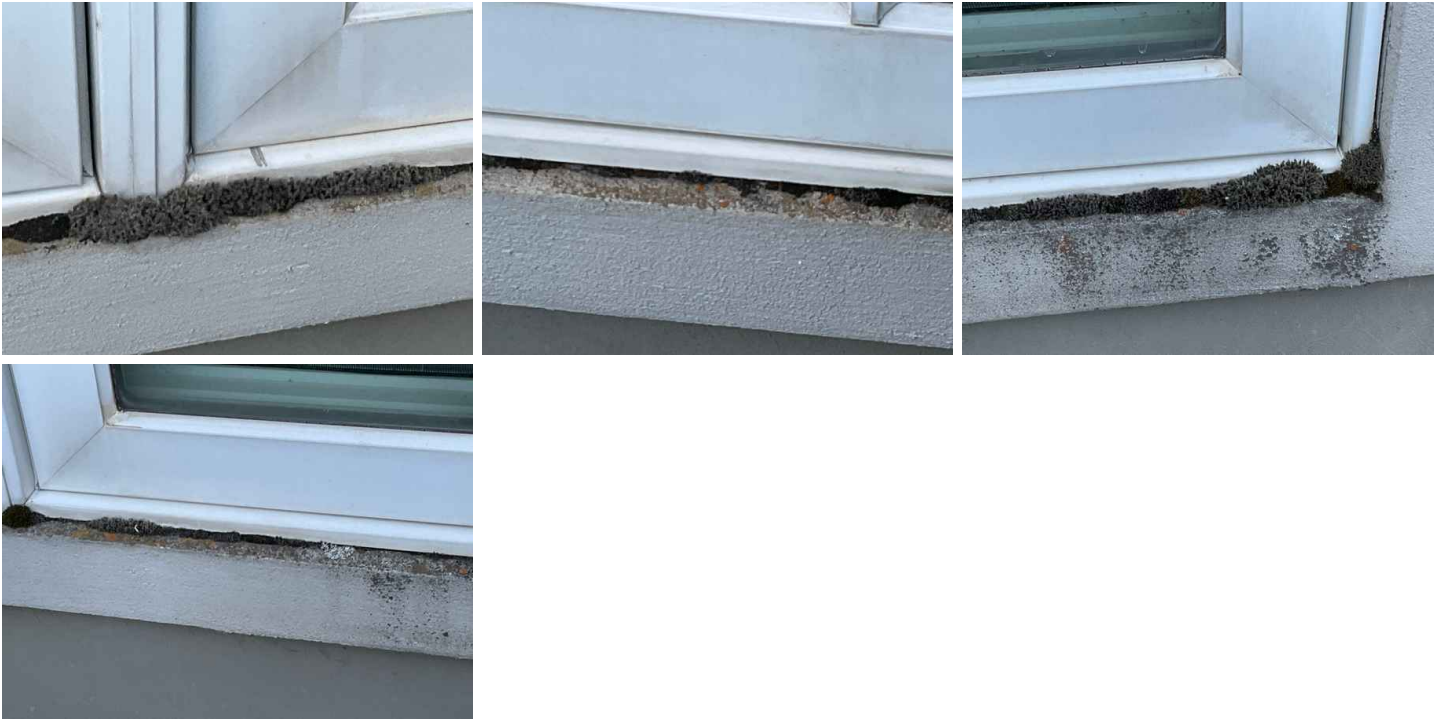
MOISTURE AT WINDOW

I observed indications of excessive moisture or water intrusion at a window. Further evaluation is recommended.

Contact a qualified window repair/installation contractor.

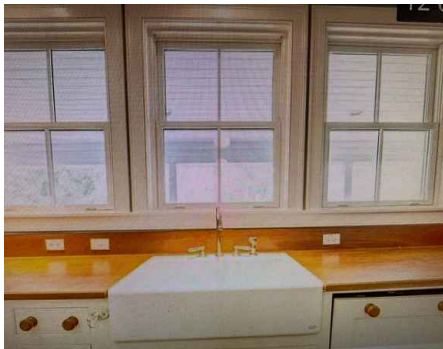
Kitchen Sink: Ran Water at Kitchen Sink

I ran water at the kitchen sink.

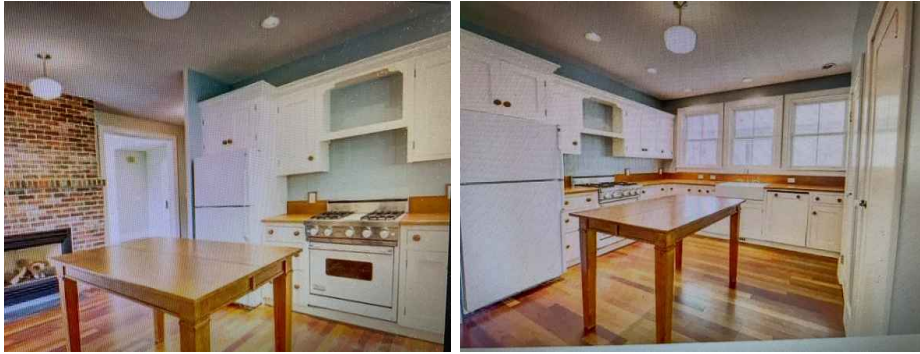
Range/Oven/Cooktop: Turned On Stove & Oven

I turned on the kitchen's stove and oven.

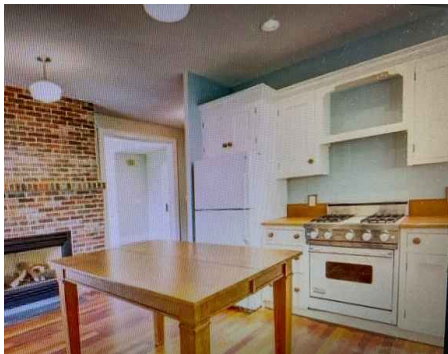
Refrigerator: Refrigerator Was On

I checked to see if the refrigerator was on. It was. I Checked if Ice Maker produced Ice, as well as Checked Temperature in Refrigerator, and Temperature on freezer. Working at time of Inspection.

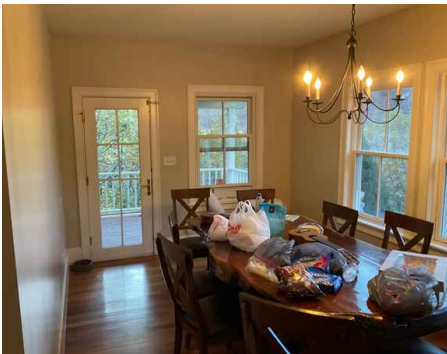
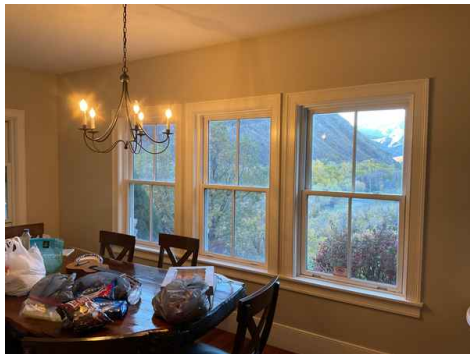
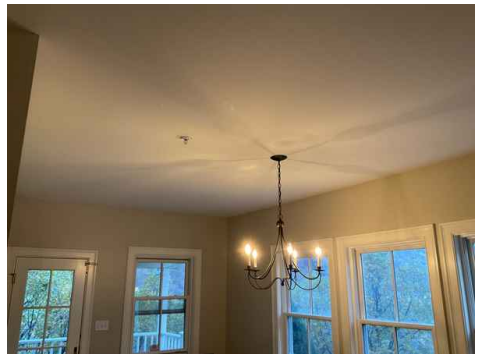
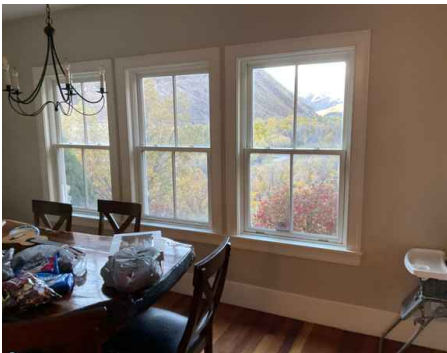
Walls: Wall Material

Drywall

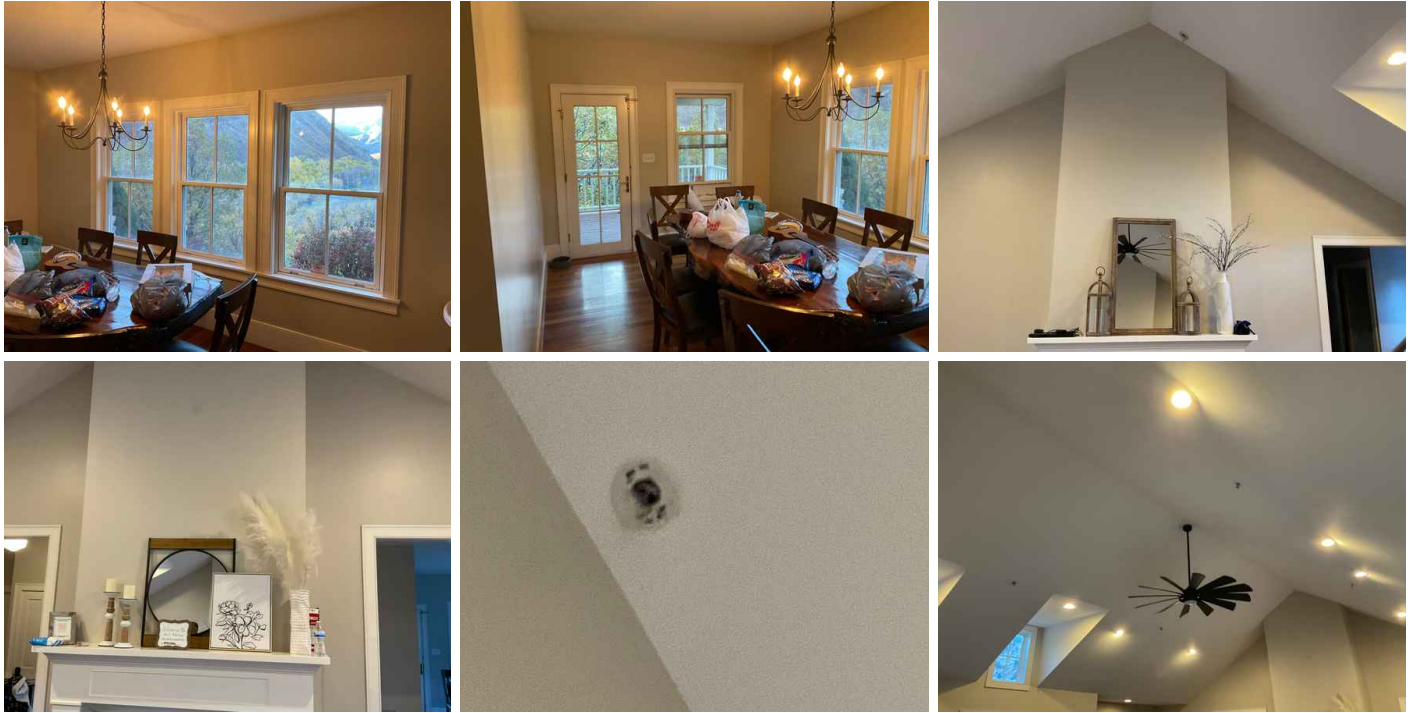
Ceilings: Ceiling Material

Gypsum Board

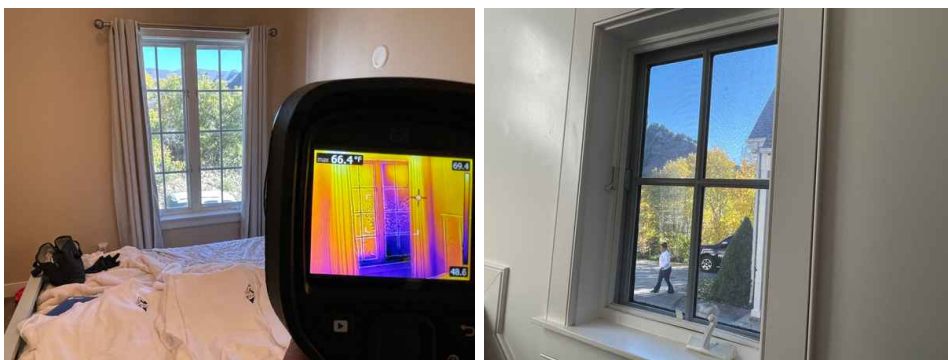
12.3.1 Windows

DAMAGED

One or more windows appears to have general damage, but are operational. Recommend a window professional clean, lubricate & adjust as necessary.

Contact a qualified window repair/installation contractor.

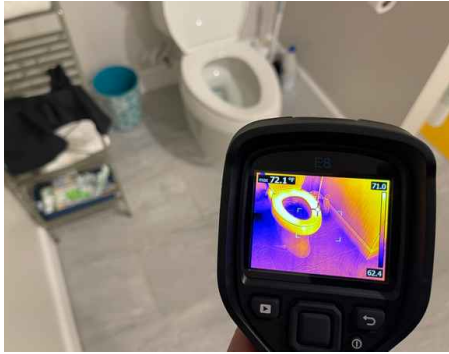
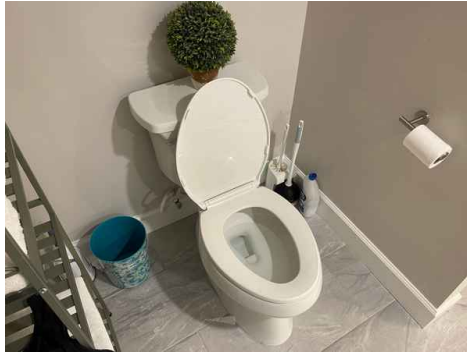
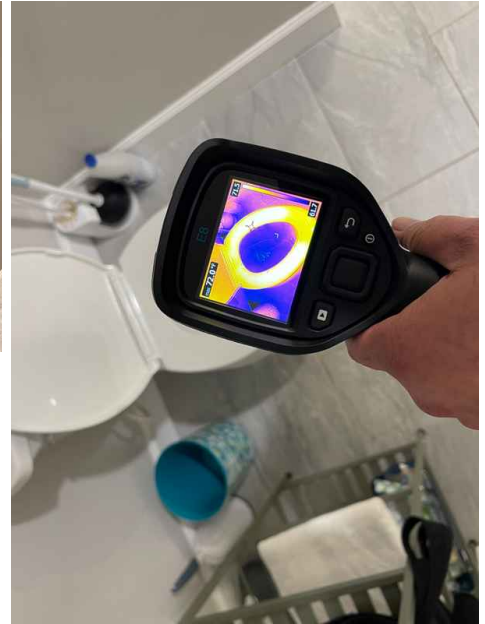
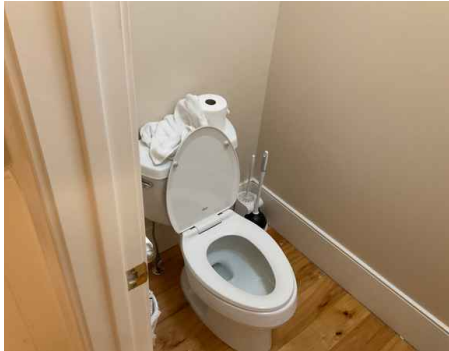
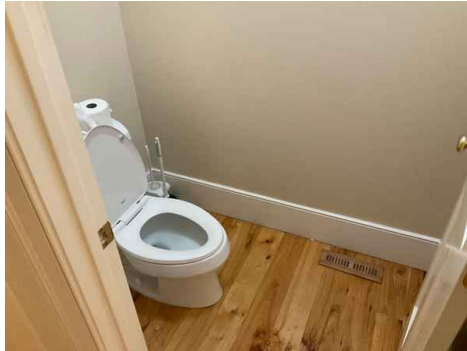
Toilet in guest bathroom did not flush, or work.

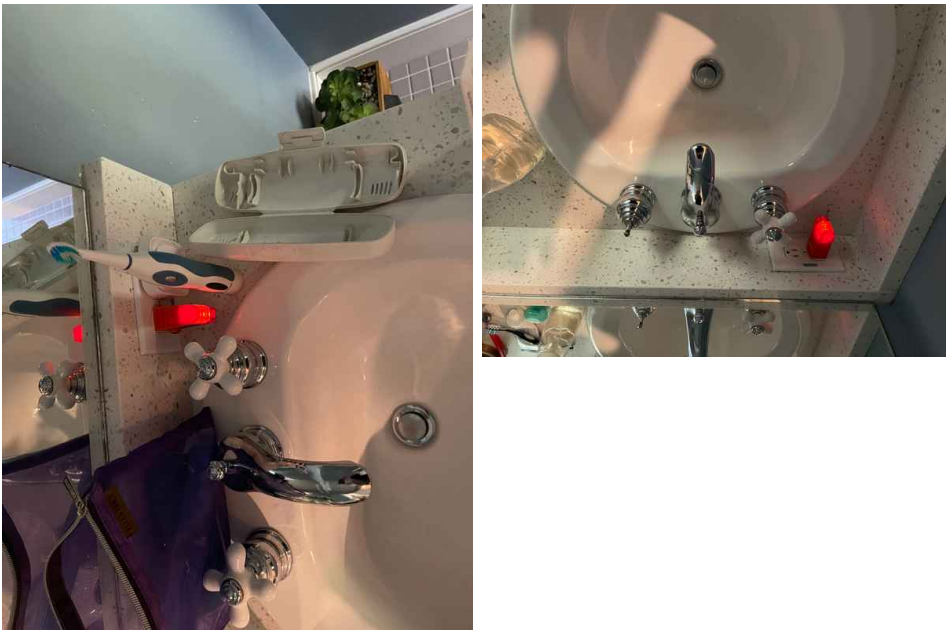
RECEPTACLE WITHIN TUB/SHOWER DEFECT

There is a receptacle within or directly over a tub or shower space. This is a hazardous condition.

Contact a qualified electrical contractor.

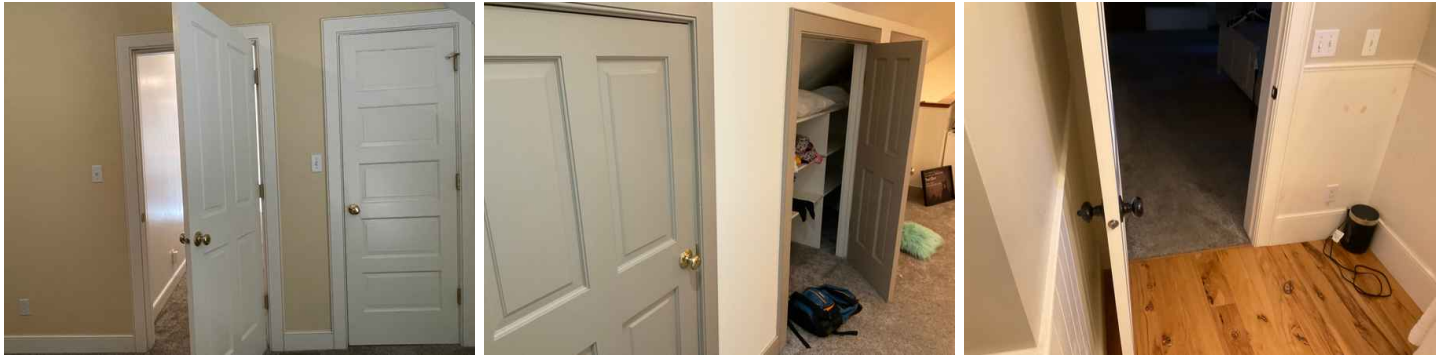
I observed that the bathroom door did not close properly.

Recommended DIY Project

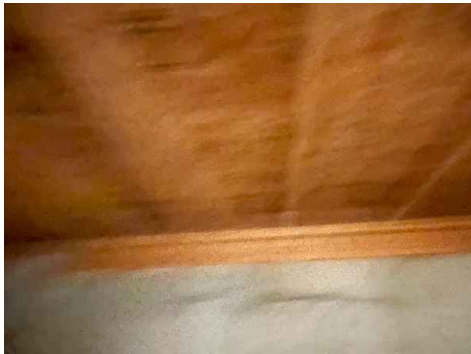
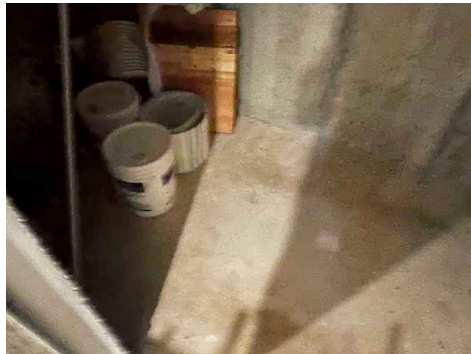
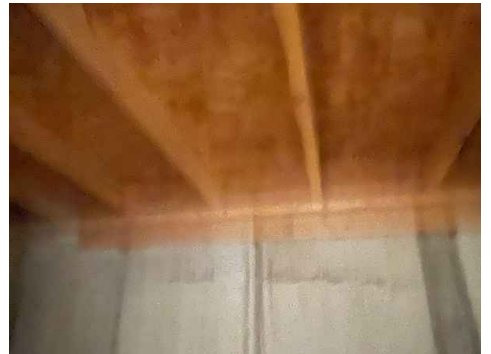
MISSING LIGHTING FOR ATTIC STORAGE

I observed a lack of lighting for the attic storage area.

Contact a qualified electrical contractor.

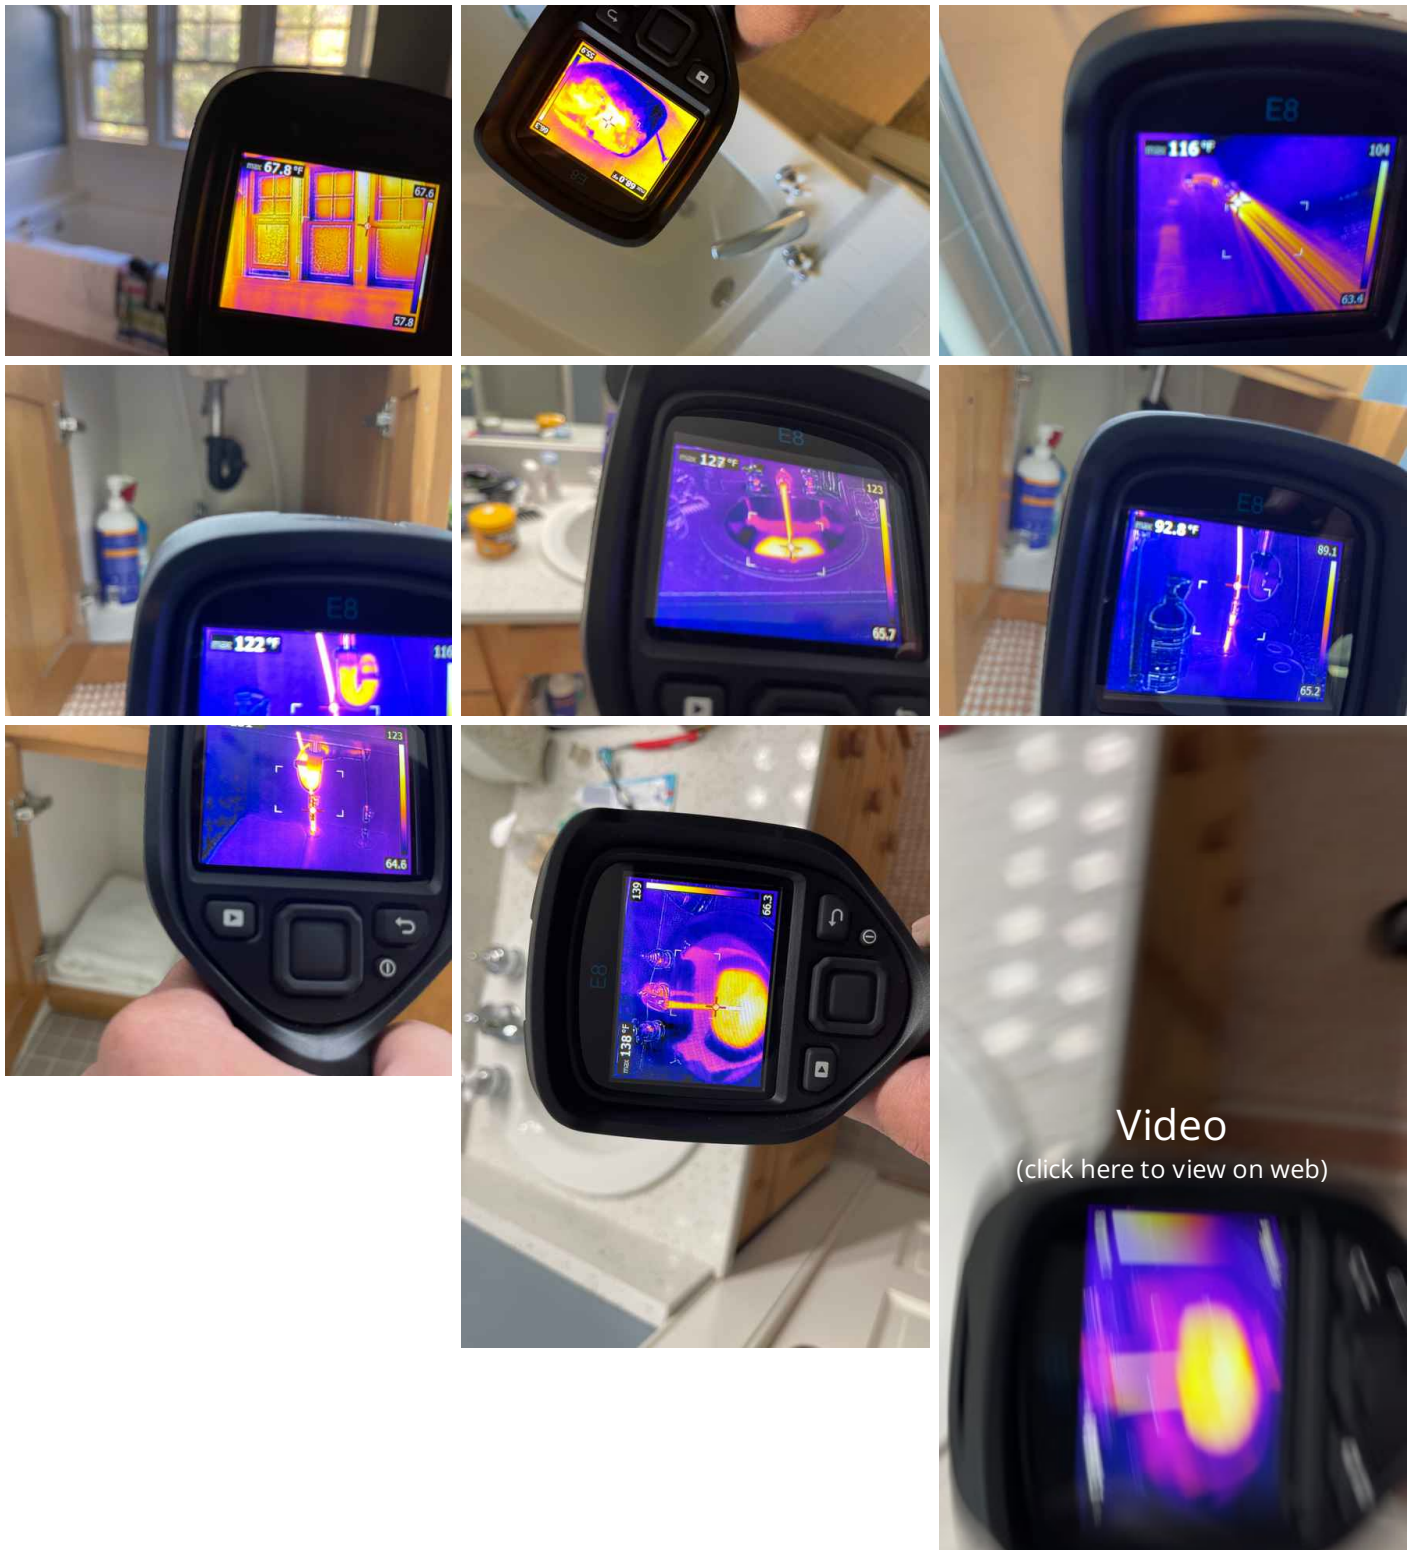
Interior Photos: Interior Photos

Infrared technology can detect heat loss, moisture damage, air leakage and inconsistencies in insulation coverage. Infrared thermography uses a thermal infrared camera to measure surface temperature and can identify abnormalities within building materials without using invasive testing.
