SUMMARY  
1234 Main Street North Las Vegas  
Nevada 89031  
Buyer Name  
02/18/2025 9:00AM

Raukee Matagi  
Inspector of Structures State of Nevada  
Department of Business and Industry  
Real Estate Division, Internachi CPI,  
CCPIA Commercial Inspector.  
Precedence 1 Inspections

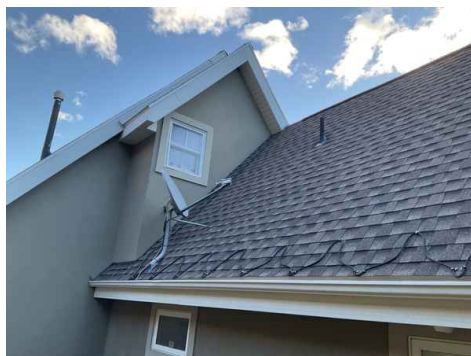
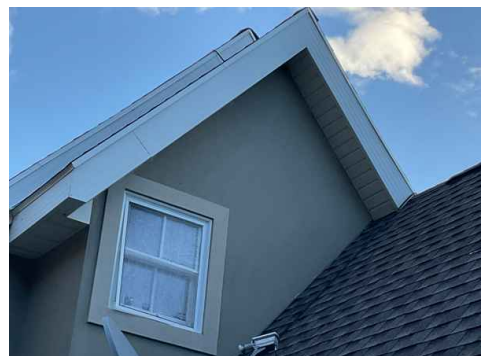
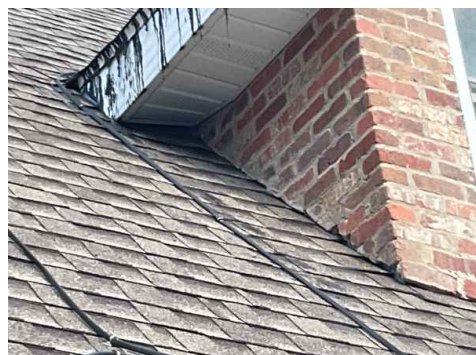
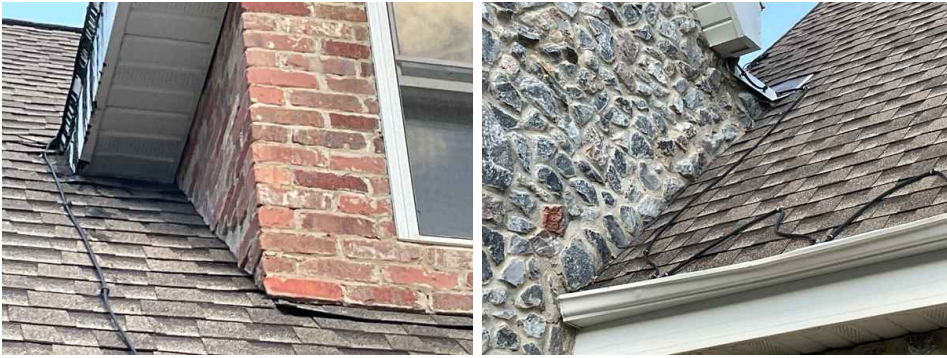
2.3.1 Flashing

**MISSING KICKOUT FLASHING**

I observed a defect at the flashing area called a "kickout." It's missing. Not installed. A kickout flashing "kicks" the roof water away from the house structure and diverts it into a gutter. This missing flashing could lead to hidden moisture intrusion and water damage issues that I would not be able to observe during a visual-only home inspection. A roofing professional is needed to further evaluate and make necessary corrections.

Recommendation  
Contact a qualified roofing professional.  
Estimated Cost  
\$10 - \$1,000

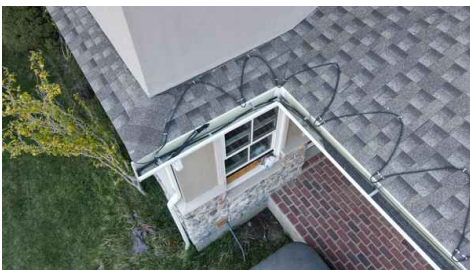
Debris inside gutter

2.5.1 Gutters & Downspouts  
**DEBRIS IN GUTTERS**

I observed debris in the gutter. Cleaning and maintenance is recommended.

Recommendation  
Contact a qualified gutter contractor

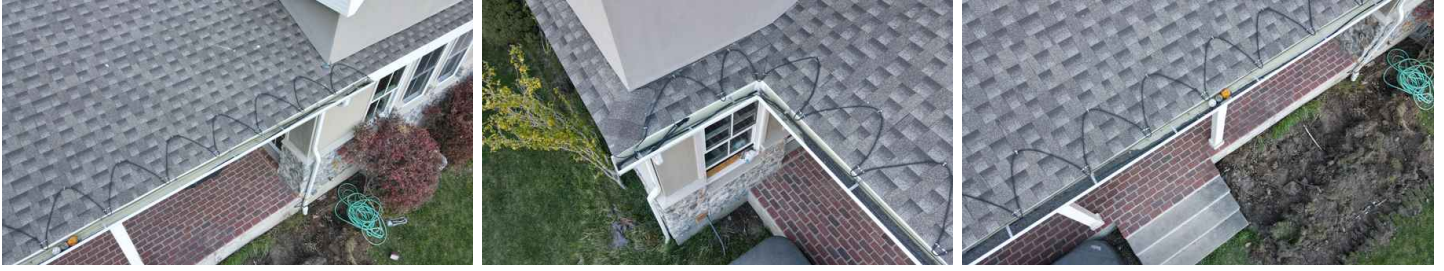
2.5.2 Gutters & Downspouts  
**GUTTER DAMAGED**

I observed damage to the gutter. This is a defect that should be corrected by a professional contractor.

Recommendation  
Contact a qualified gutter contractor

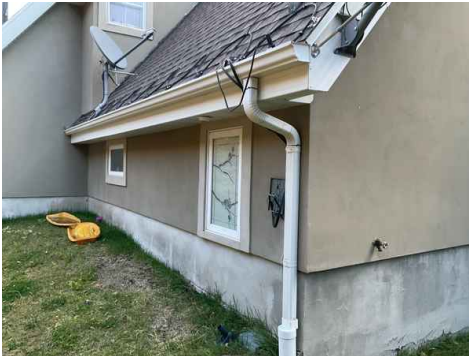
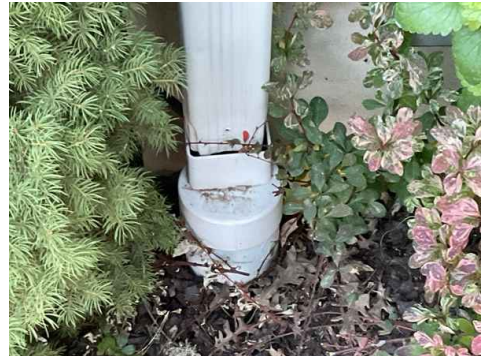
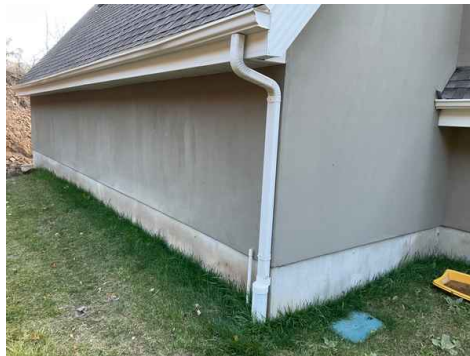
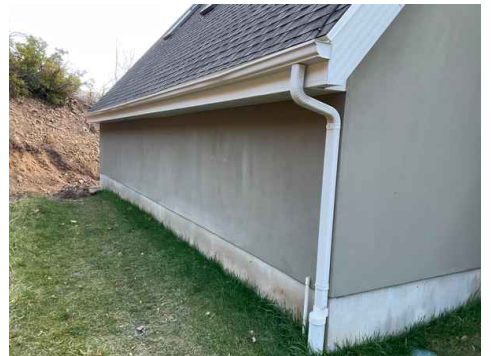
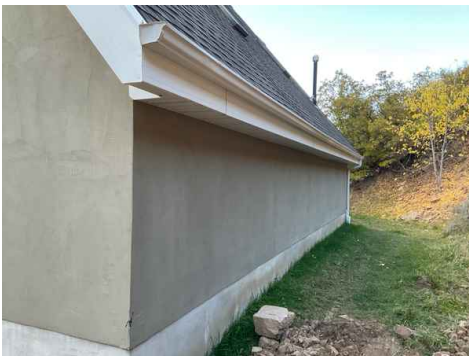
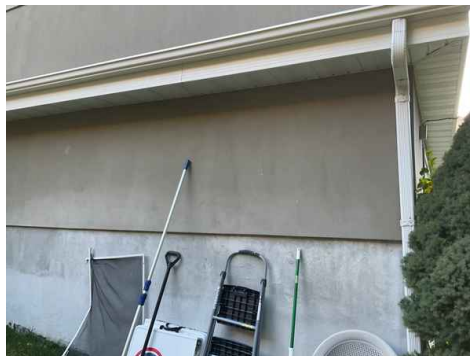
### 2.5.3 Gutters & Downspouts

#### DOWNSPOUTS DRAIN NEAR HOUSE

One or more downspouts drain too close to the home's foundation. This can result in excessive moisture in the soil at the foundation, which can lead to foundation/structural movement. Recommend a qualified contractor adjust downspout extensions to drain at least 6 feet from the foundation. A handy homeowner should be able to do this project.

Recommended DIY Project

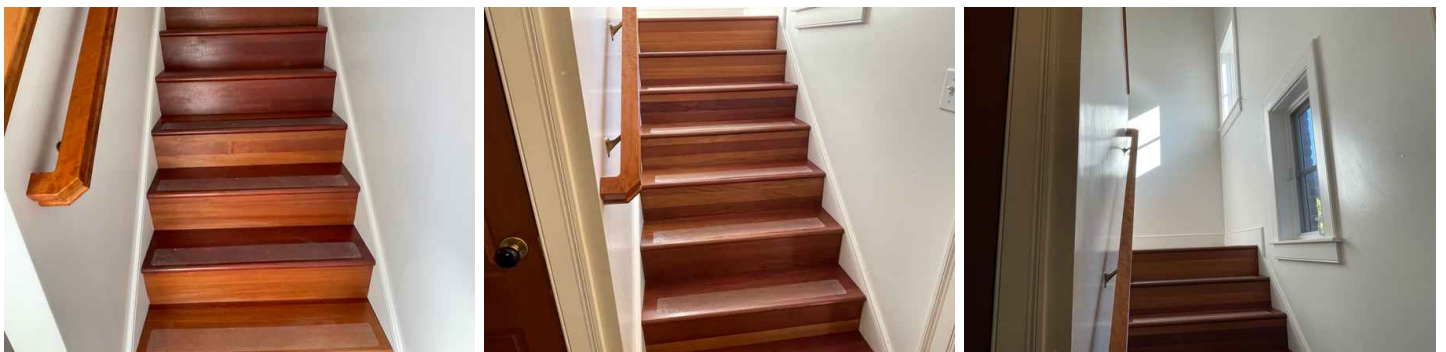
### 3.7.1 Stairs, Steps, Stoops, Stairways & Ramps

#### TRIP HAZARD AT STEP

I observed a trip hazard at a step. This condition is a safety hazard.

Correction and further evaluation is recommended.

Contact a qualified general contractor.

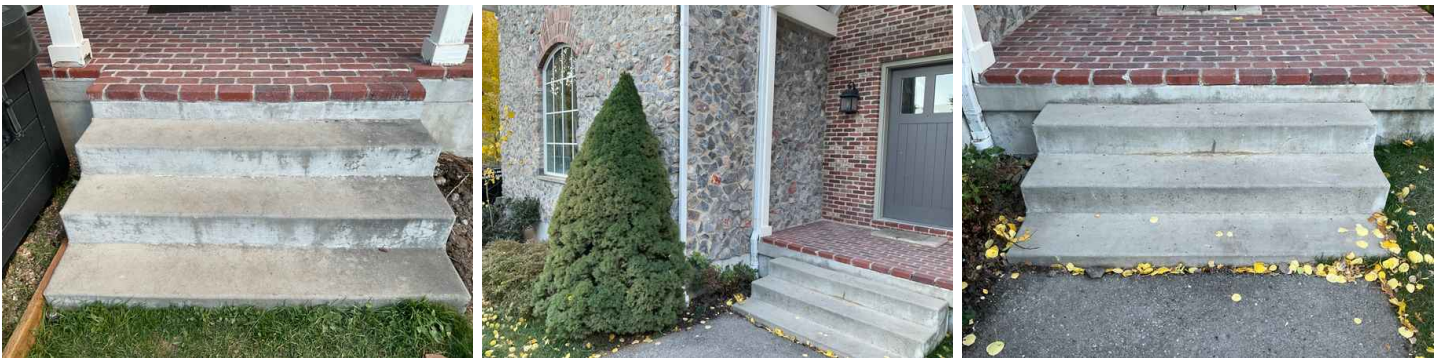
### 3.7.3 Stairs, Steps, Stoops, Stairways & Ramps

#### **RISER HEIGHT TOO TALL (GREATER THAN 7 3/4")**

I observed a defect at the stair riser height.

The riser height maximum is 7 3/4 inches measured vertically between the stair treads. This poses a trip hazard.

Contact a qualified professional.

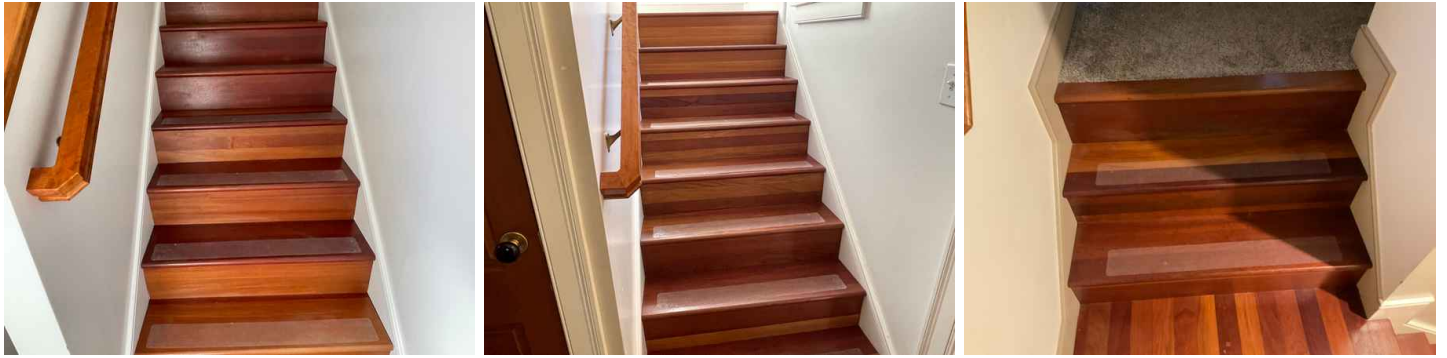
### 3.7.4 Stairs, Steps, Stoops, Stairways & Ramps

#### **TREAD DEPTH TOO SHORT (SMALLER THAN 10")**

I observed a defect at the stair riser depth. It's too short.

The minimum tread depth is 10 inches, measured between the projected nosings of adjacent treads. This poses a trip hazard.

Contact a qualified professional.

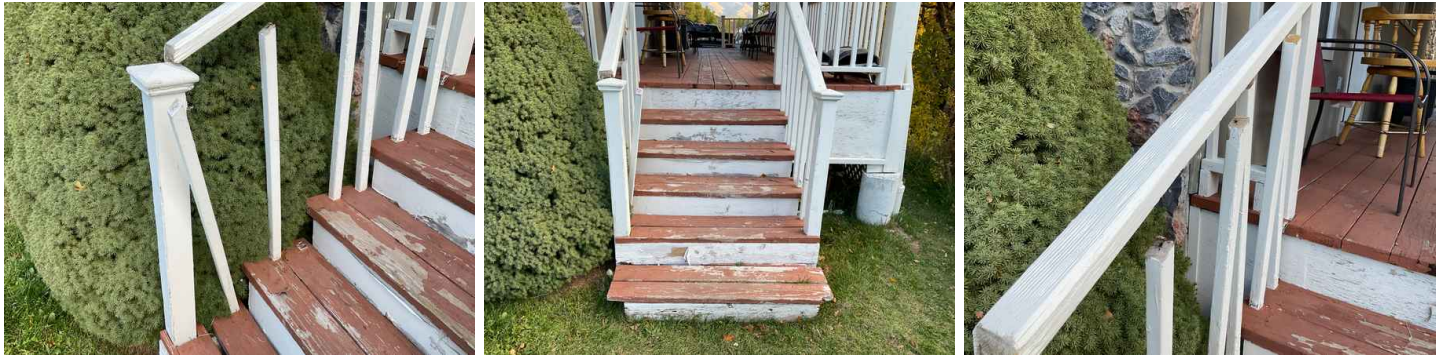
3.8.3 Porches, Patios, Decks, Balconies & Carports

**MISSING HANDRAIL**

I observed a missing handrail.

There is more than one step here, and I recommend installing a handrail for safety.

Contact a qualified professional.

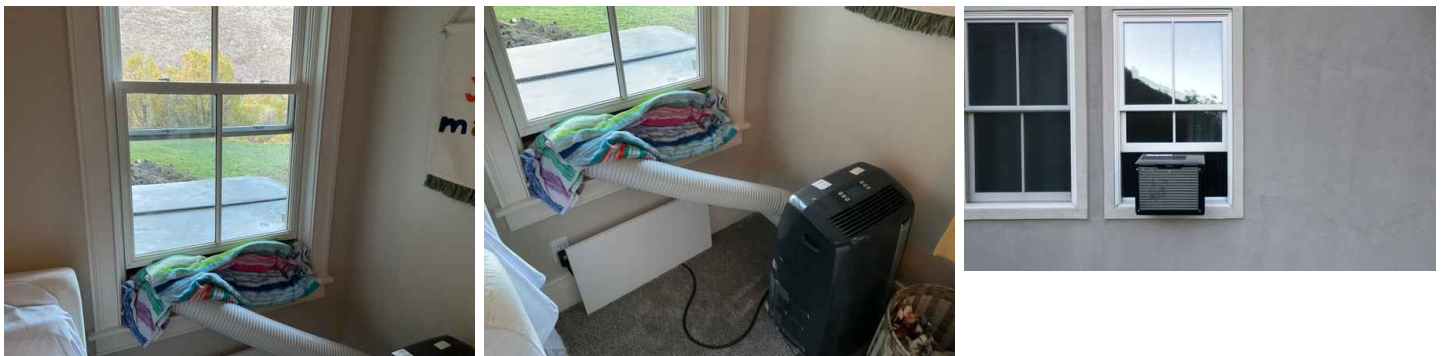
5.1.1 Cooling System Information

**COOLING SYSTEM DID NOT OPERATE**

I observed that the heating system did not operate. Correction and further evaluation is recommended.

Contact a qualified HVAC professional.

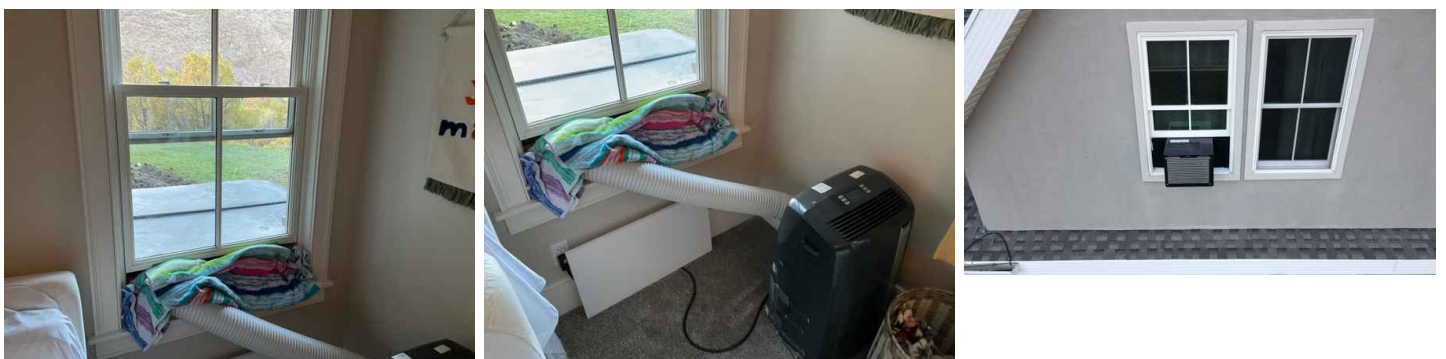
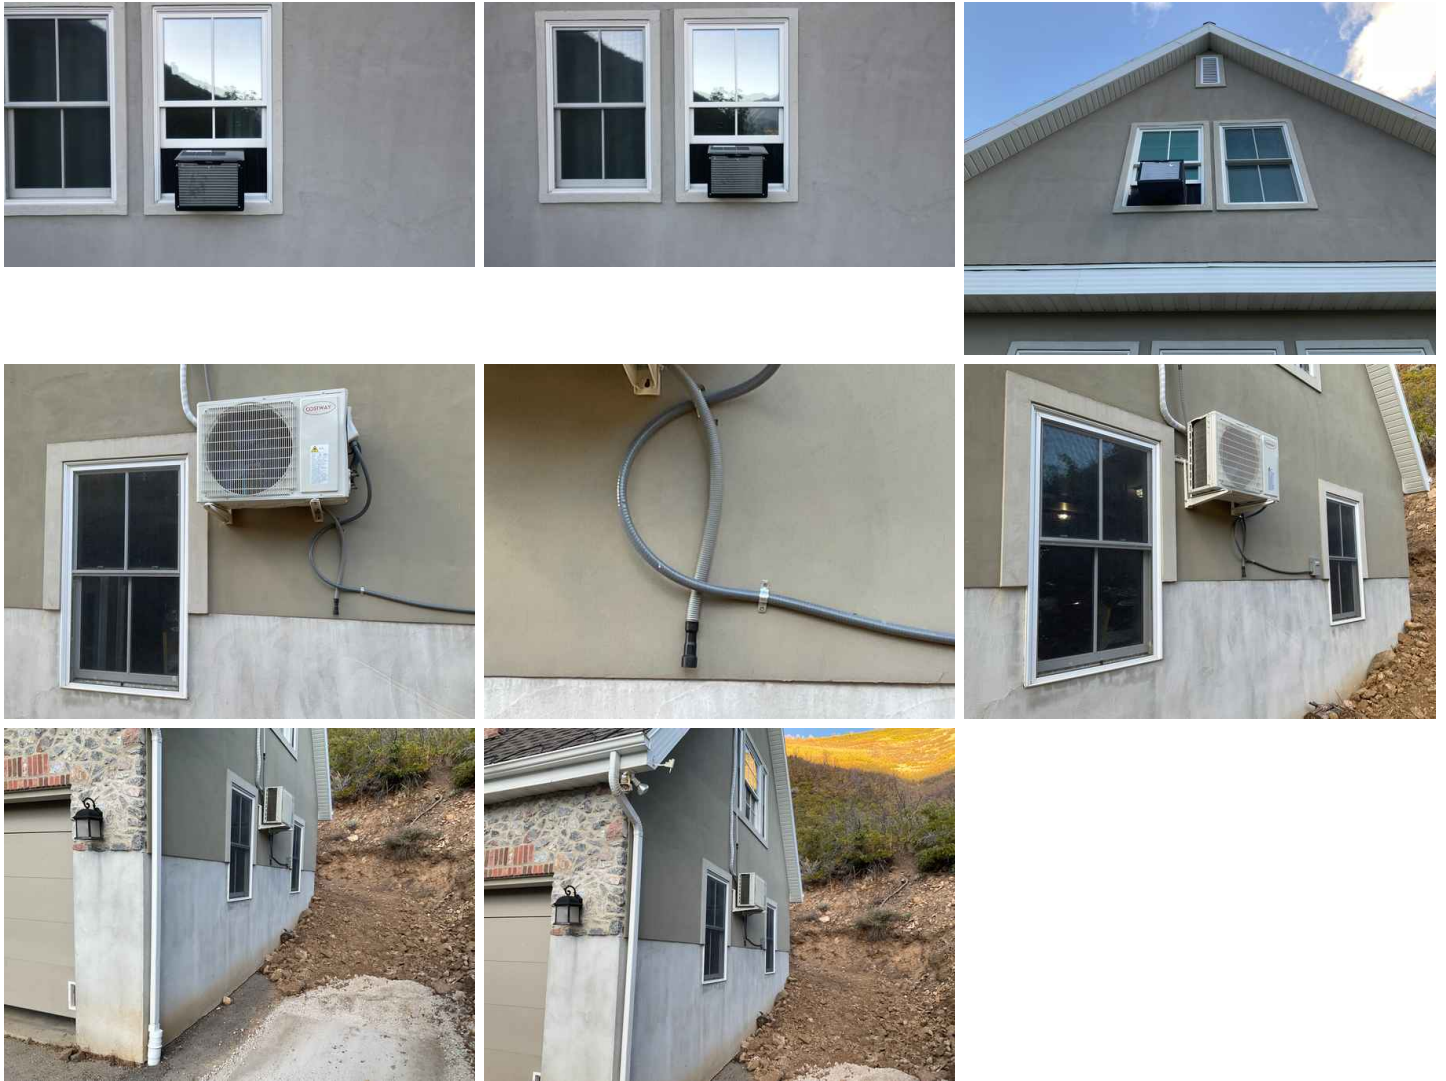
5.1.2 Cooling System Information

**POWER WAS SHUT OFF PRIOR TO INSPECTION**

I observed that the cooling system was turned off prior to my home inspection.

Condensing unit can be damaged if it's operated immediately after power is restored. Recommend power be restored for at least 8 hours and unit evaluated by licensed HVAC contractor.

Contact a qualified HVAC professional.

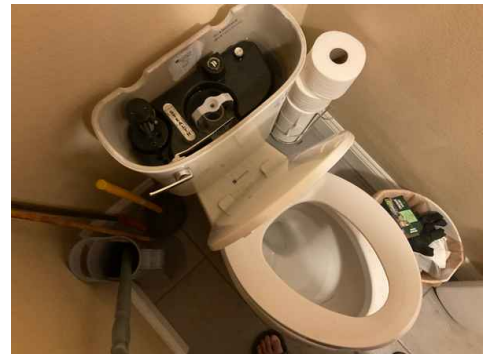
6.6.1 Water Supply & Distribution Systems  
**TOILET TANK COMPONENT DEFECT**

I observed indications of a toilet that had tank components that did not operate.

Recommendation  
Contact a qualified plumbing contractor.

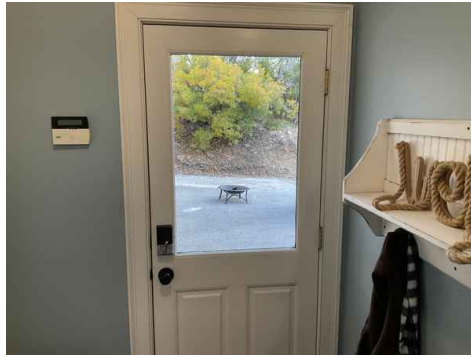
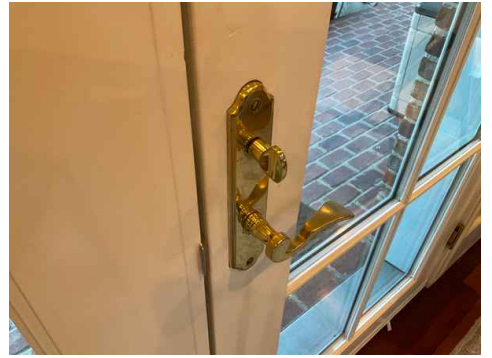
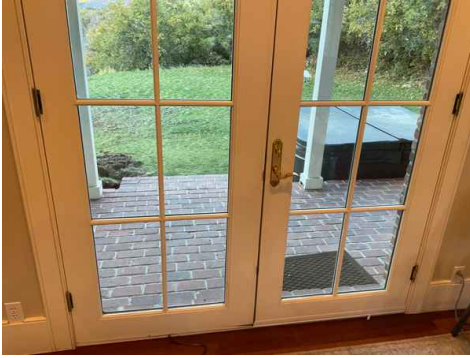
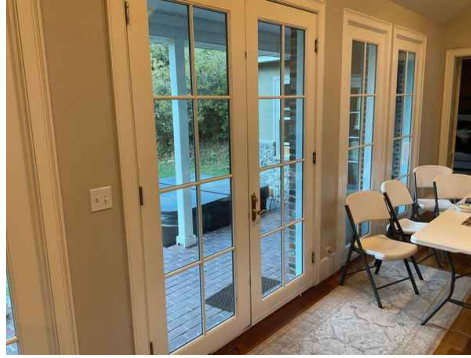
9.1.1 Doors  
**DOOR STICKS**

I observed that the door sticks.

Recommendation  
Contact a qualified handyman.

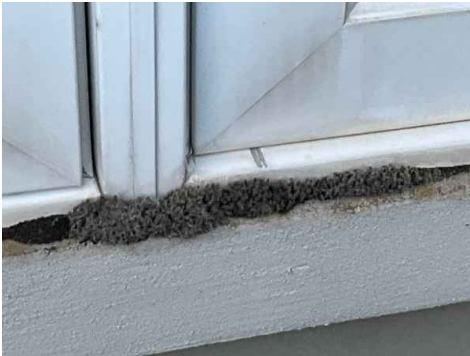
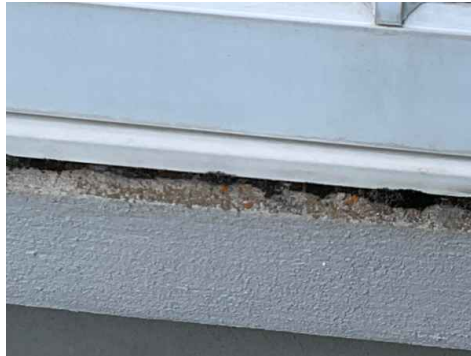
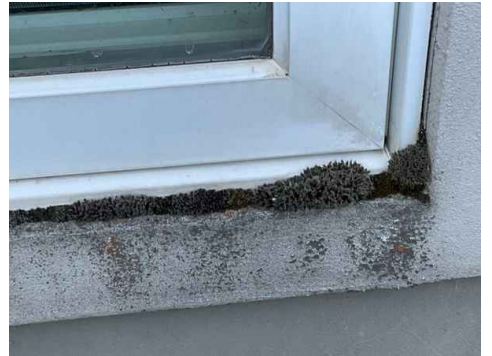
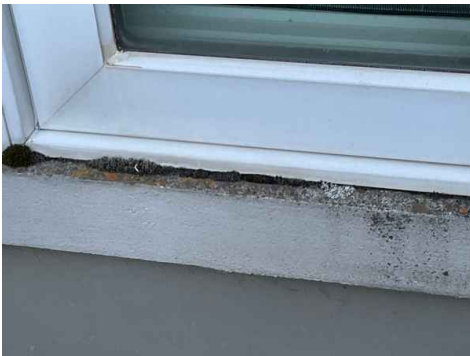
9.2.1 Windows

**MOISTURE AT WINDOW**

I observed indications of excessive moisture or water intrusion at a window. Further evaluation is recommended.

Recommendation  
Contact a qualified window repair/installation contractor.

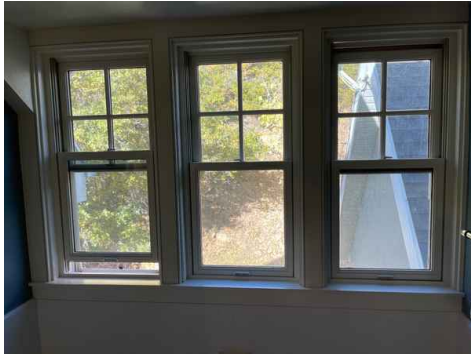
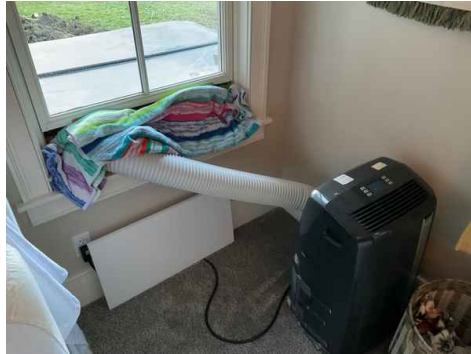
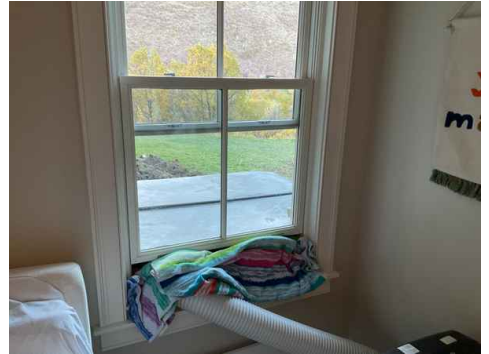
9.2.2 Windows

**FOGGED / BROKEN SEALS**

I observed more than one fogged windows and broken seals that caused condensation between window panes.

Contact a qualified window repair/installation contractor.

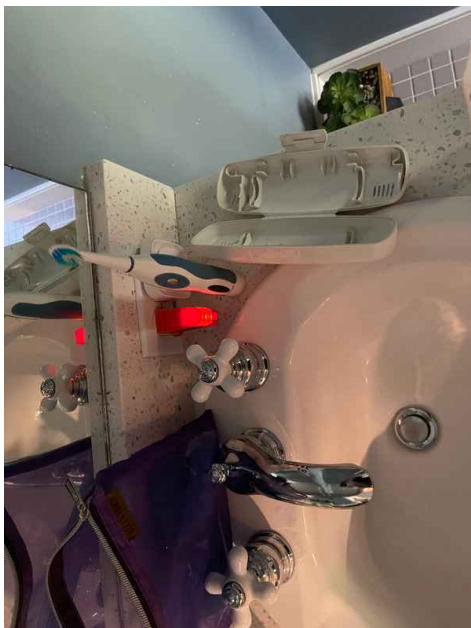
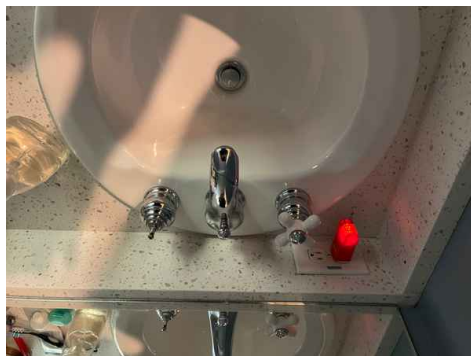
9.3.2 Switches, Fixtures & Receptacles

**MAJOR DEFECT**

I observed indications of a major defect during the inspection. Major defect. Hazard. Correction and further evaluation is recommended.

Contact a qualified electrical contractor.

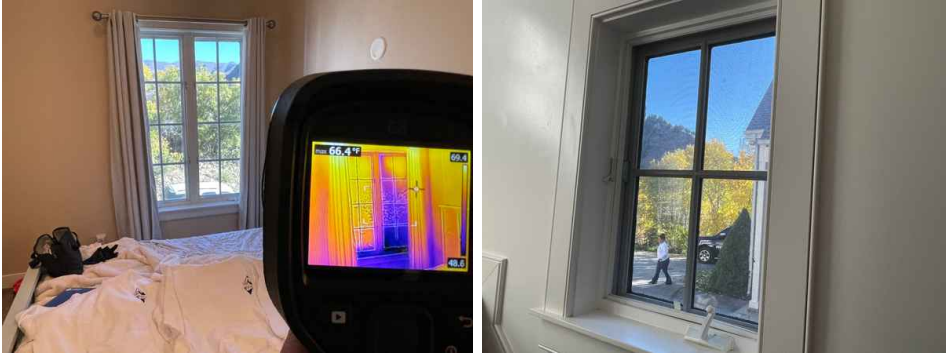
## 12.3.1 Windows

**DAMAGED**

One or more windows appears to have general damage, but are operational. Recommend a window professional clean, lubricate & adjust as necessary.

Contact a qualified window repair/installation contractor.

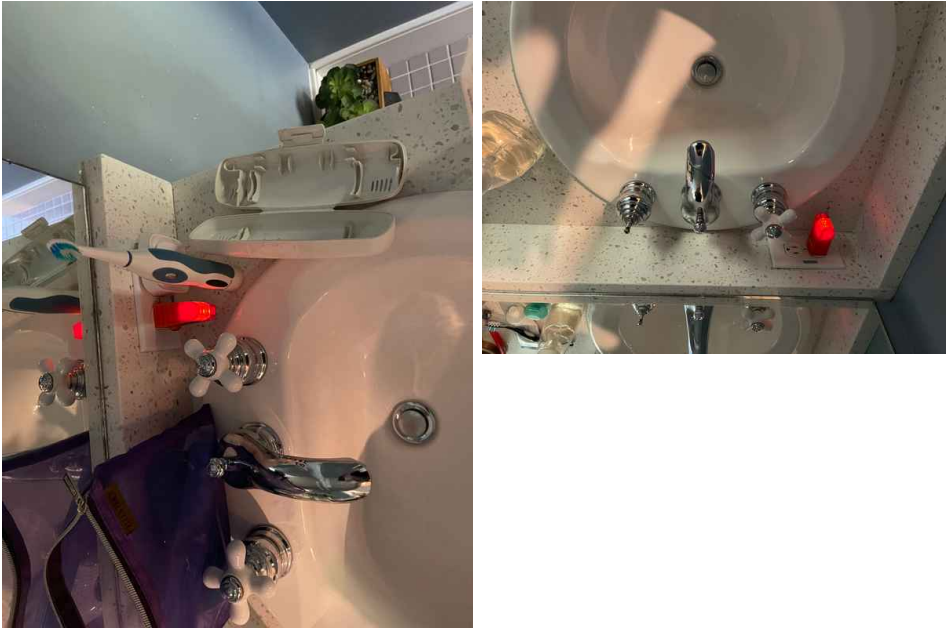
## 13.4.1 GFCI &amp; Electric in Bathroom

**RECEPTACLE WITHIN TUB/SHOWER DEFECT**

There is a receptacle within or directly over a tub or shower space. This is a hazardous condition.

Contact a qualified electrical contractor.

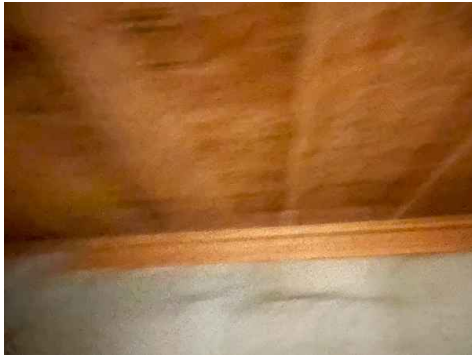
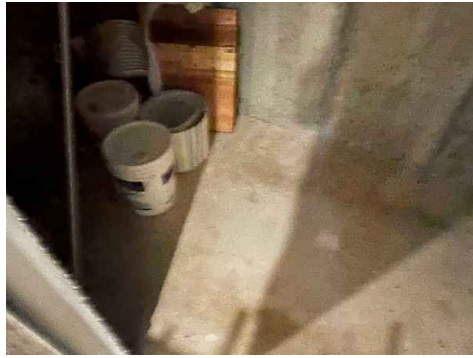
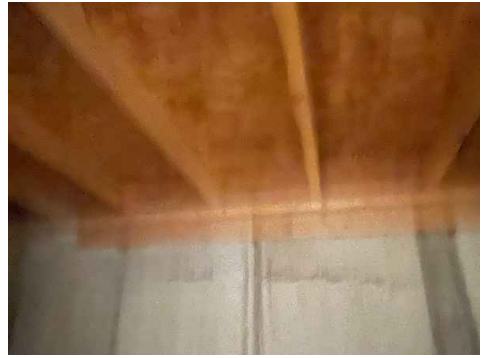
## 17.1.1 Structural Components &amp; Observations in Attic

**MISSING LIGHTING FOR ATTIC STORAGE**

I observed a lack of lighting for the attic storage area.

Areas used for storage require a switched lighting outlet.

Contact a qualified electrical contractor.
